Assessment of the USAF Aircraft Accident
Investigation Board (AIB) Report on the F-22A Mishap
of November 16, 2010

SUBJECT: Assessment of the USAF Aircraft Accident Investigation Board (AIB) Report on the F-22A Mishap of November 16, 2010 (Report No. DODIG-2013-041)

UNITED STATES AIR FORCE
AIRCRAFT ACCIDENT INVESTIGATION
BOARD REPORT

F-22A, T/N 06-4125

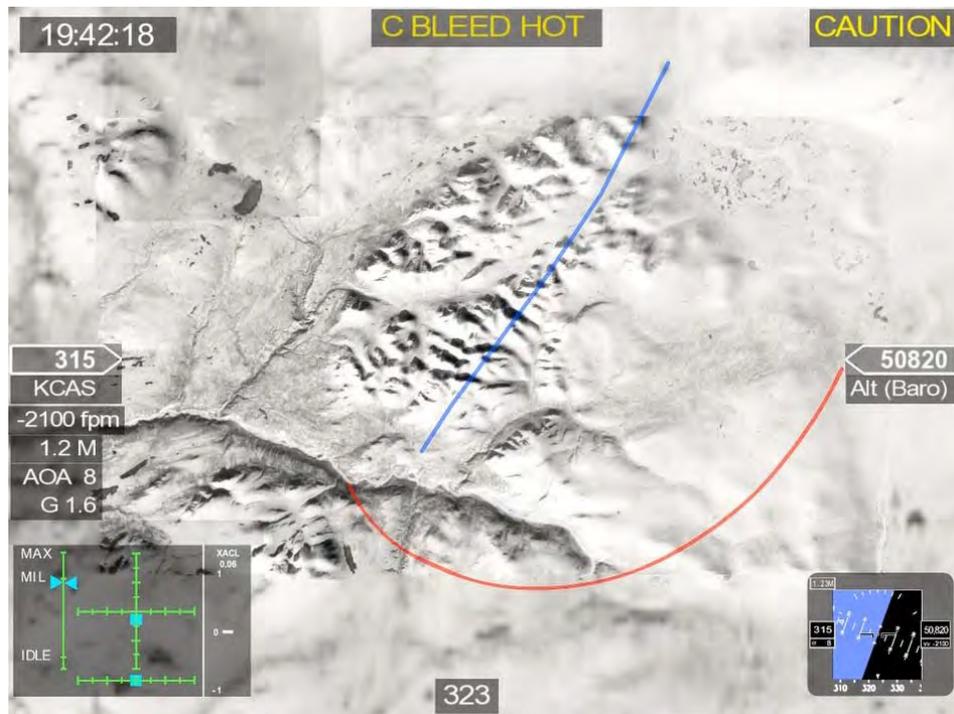
Figure 1 19:42:18L -- Relative position between MFL (blue) and MP (red) at the assertion of the C BLEED HOT caution ICAW. (Tab EE)

At 19:42:18L the fire protection system (FPS) detected a bleed air leak in the center bleed air ducting from both engines. In response to the FPS, the Integrated Vehicle Subsystem Controller (IVSC) asserted the C BLEED HOT caution ICAW while it requested the Environment Control System (ECS) to isolate the center bleed system. “CAUT” was displayed in the heads up display (HUD) advising the MP of the caution ICAW. (Tab J-4) When the C BLEED HOT caution ICAW asserted, the following functions were lost:

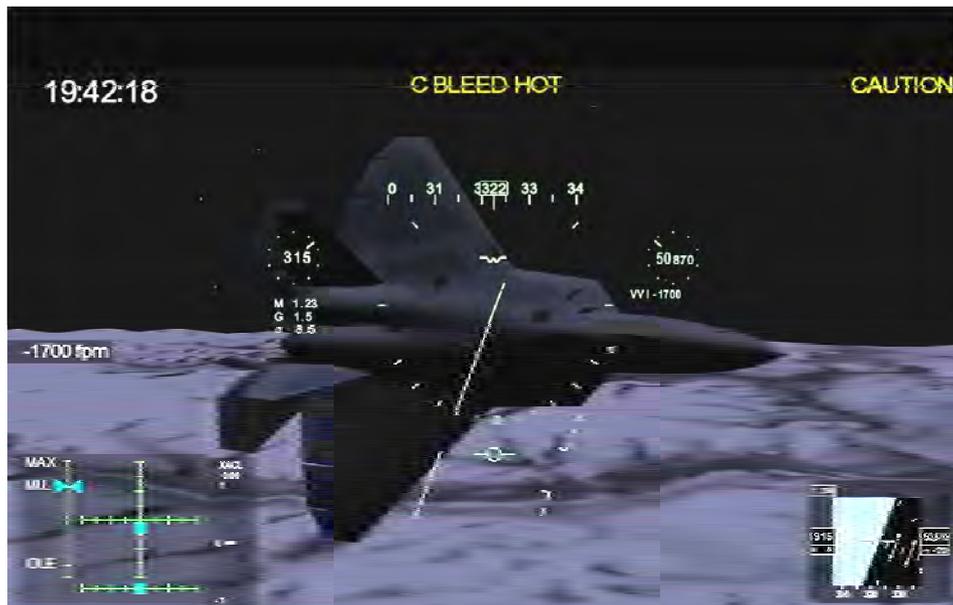
Figure 2 19:42:18 -- MA parameters at assertion of C BLEED HOT caution ICAW. (Tab EE) See Tab Z-10 for a diagram explaining the symbology in the Figures.

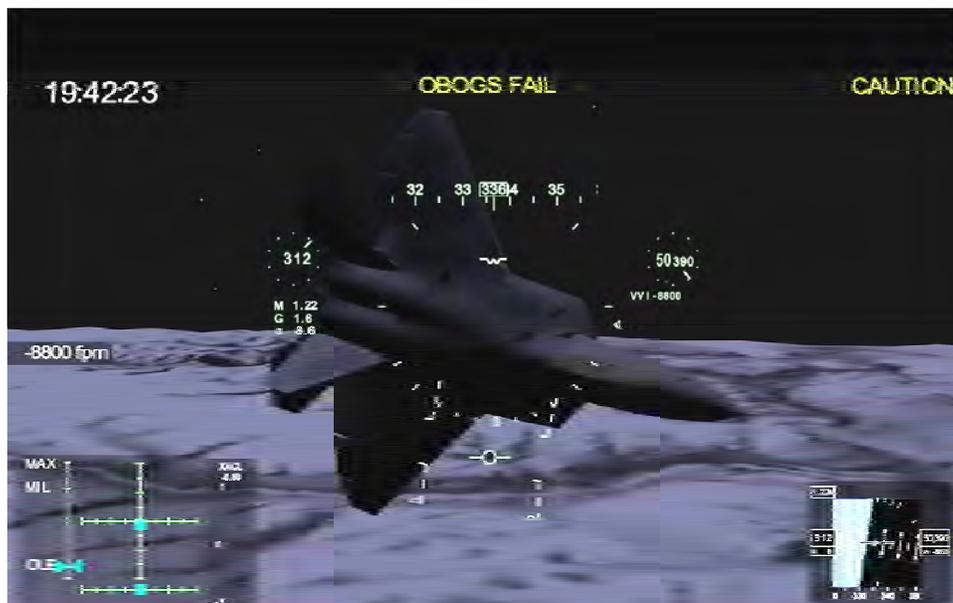
Figure 3 19:42:23 – MA parameters at assertion of OBOGS FAIL caution ICAW. (Tab EE)

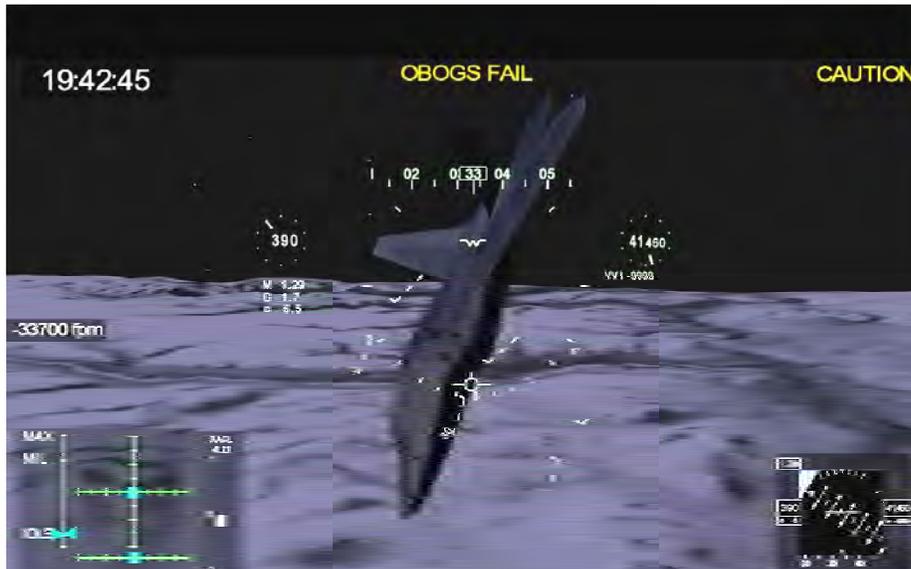
Figure 4 19:42:45 – MP deliberately flew to a controlled attitude of 30 degrees ND and 44 degrees RWD in order to descend to a lower altitude IAW the checklist. (Tab EE)

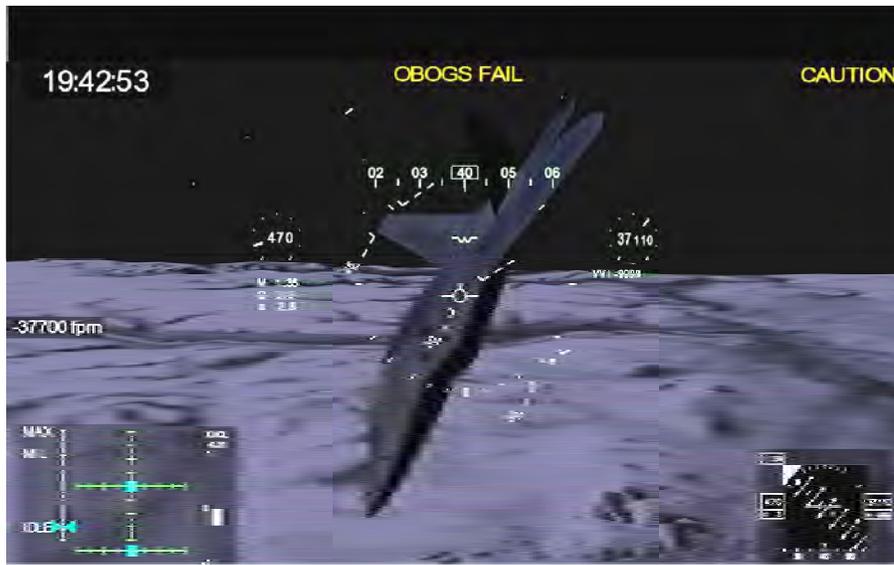
The CSMU mishap data discrete signal showed partial pressure to the MP's oxygen mask stopped shortly after 19:42:37L, which would lead to severely restricted breathing. (Tab J-43) From 19:42:45L until 19:42:53L, the MP made no inputs to the stick, pedals, or throttles, and the MA maintained a relatively stable bank angle and attitude. The MA was at 37,110 ft MSL, 470 KCAS, 1.35M, 30 degrees ND, 46 degrees RWD, 0.8 g, with a VVI of -37,700 fpm. (Tab EE)

Figure 5 19:42:53 – MA parameters after 8 seconds of zero MP inputs to stick, pedals, or throttles. (Tab EE)

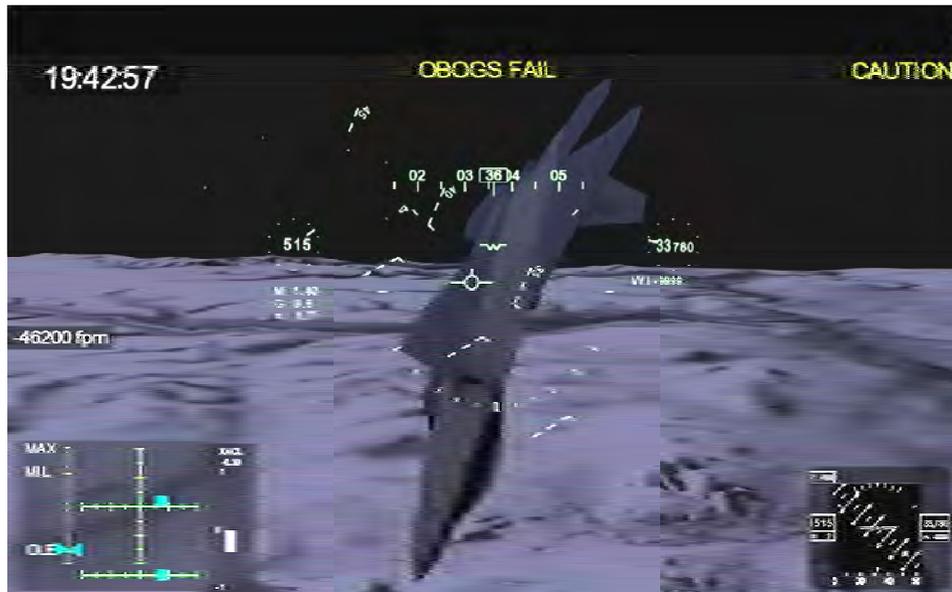
At 19:42:53L, the MP input a combination of right forward stick and right pedal which initiated a 240 degree descending right roll at greater than 45 degrees per second. (Tab EE)

Figure 6 19:42:57 – MA parameters during MA 240 degree roll to the right resulting from stick and pedal inputs. (Tab EE)

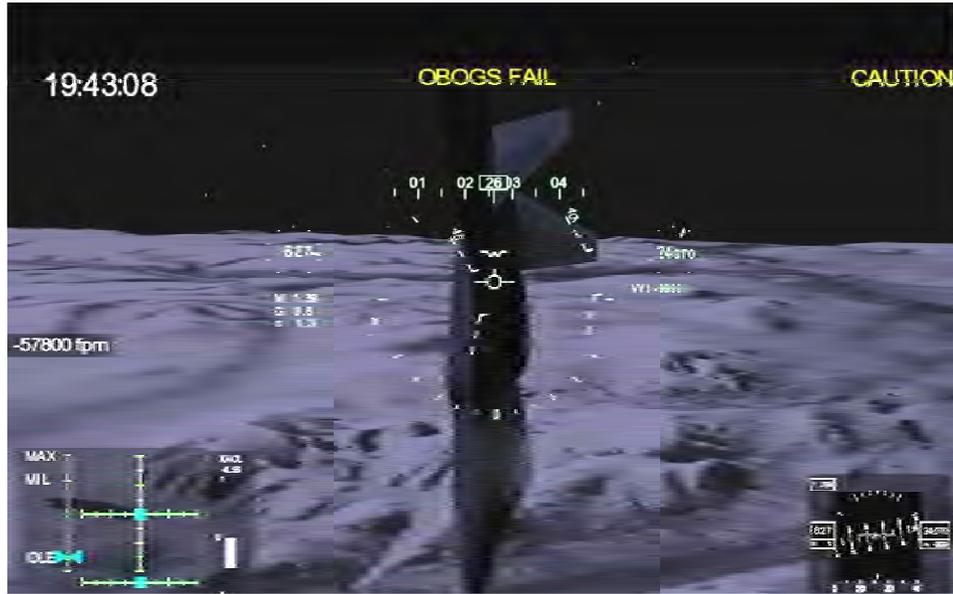
At the completion of these stick and pedal inputs at 19:43:08L, the MA had rolled through inverted, experienced less than 1 g of gravitational force, and went from a RWD to Left Wing Down (LWD) attitude, and the descent rate of the aircraft significantly increased. The parameters at this time were 24,070 ft MSL, 627 KCAS, 1.39M, 44 degrees ND, 81 degrees LWD, 0.8 g, with a VVI of -57,800 fpm. (Tab EE)

Figure 7 19:43:08 – MA parameters when stick and pedal inputs cease after the 240 degree roll. (Tab EE)

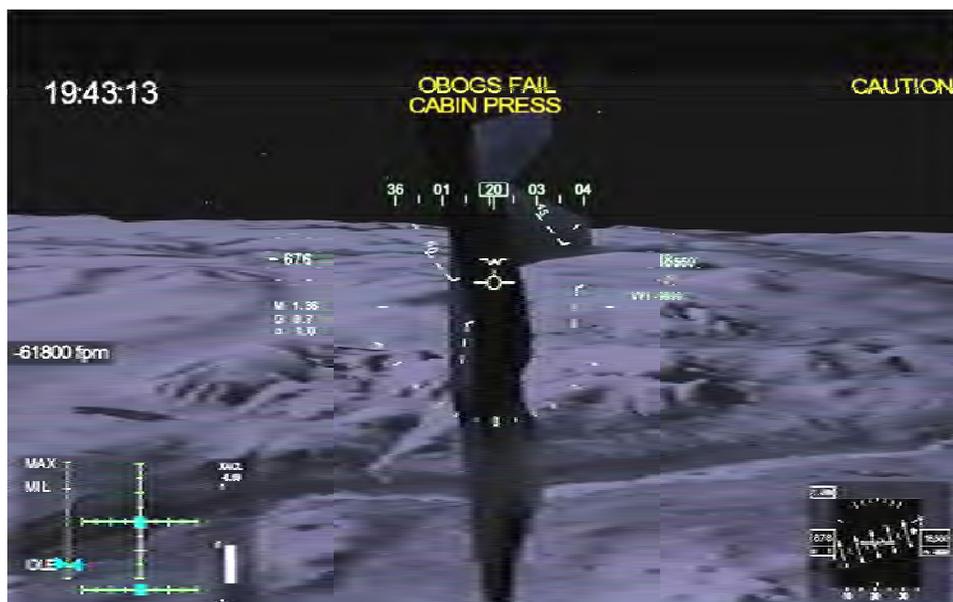
After 19:43:08L, there were no stick inputs and only very minor pedal inputs for the next 15 seconds. At 19:43:13L, passing approximately 19,000 ft MSL, a CABIN PRESSURE caution ICAW asserted based on cockpit pressurization exceeding its normal schedule. (Tab J-13)

Figure 8 19:43:13 – MA parameters at assertion of CABIN PRESS caution ICAW. No stick or pedal inputs. (Tab EE)

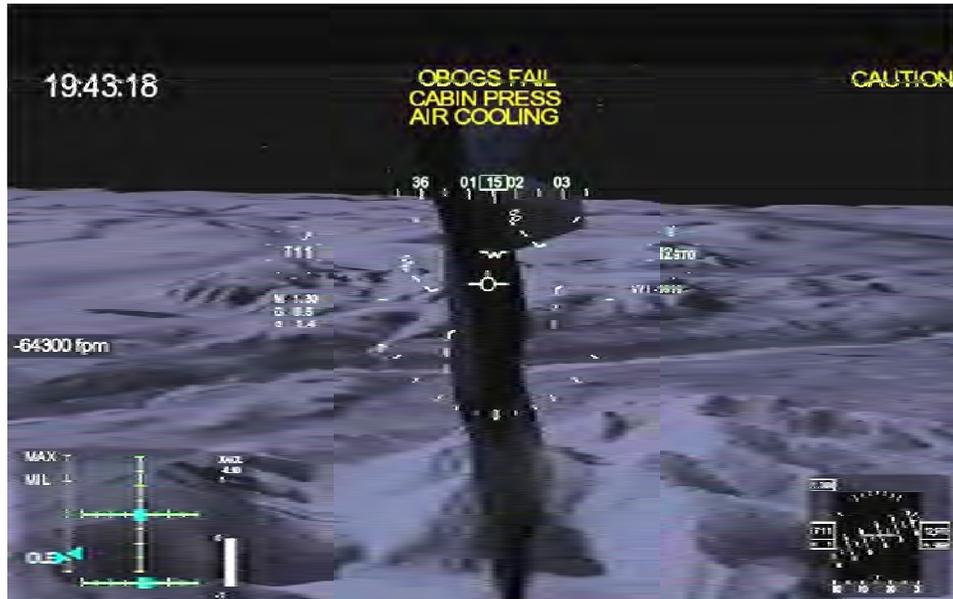
At 19:43:18L, passing 12,400 ft MSL, an AIR COOLING caution ICAW asserted. This ICAW would assert 60 seconds after a C BLEED HOT caution ICAW if the aircraft were not receiving an adequate cooling air source to its avionics. (Tab J-13)

Figure 9 19:42:18 – MA parameters at assertion of AIR COOLING caution ICAW. No stick or pedal inputs. (Tab EE)

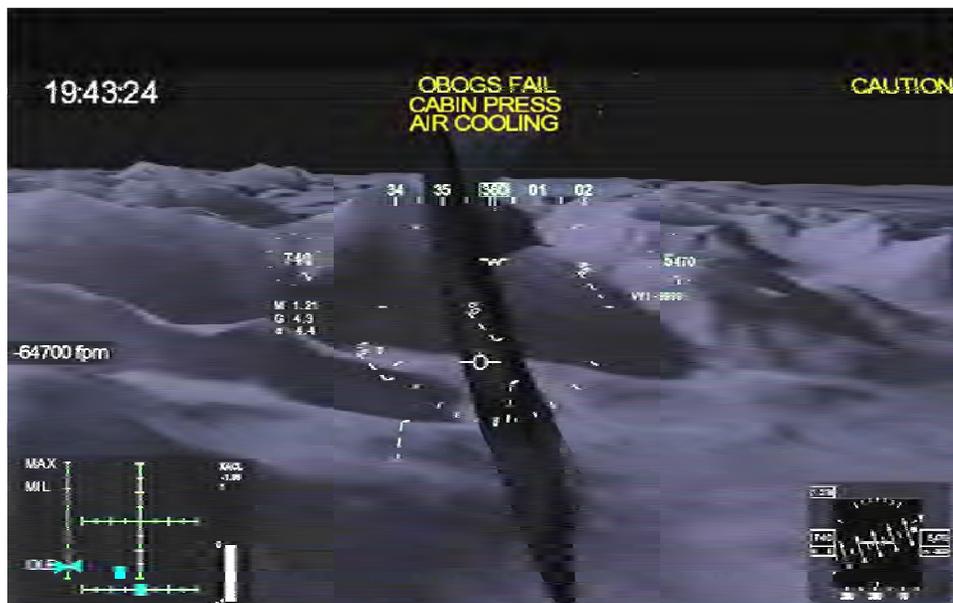
At 19:43:24L the MP performed a dive recovery at 5,470 ft MSL by pulling aft on the stick, producing a 7.4 g pull up maneuver. The MA impacted the ground 3 seconds later, inflicting fatal injuries to the MP and destroying the MA. (Tab EE)

Figure 10 19:43:24 – MP initiates full aft stick pull to start dive recovery at 5,470 ft MSL. (Tab EE)

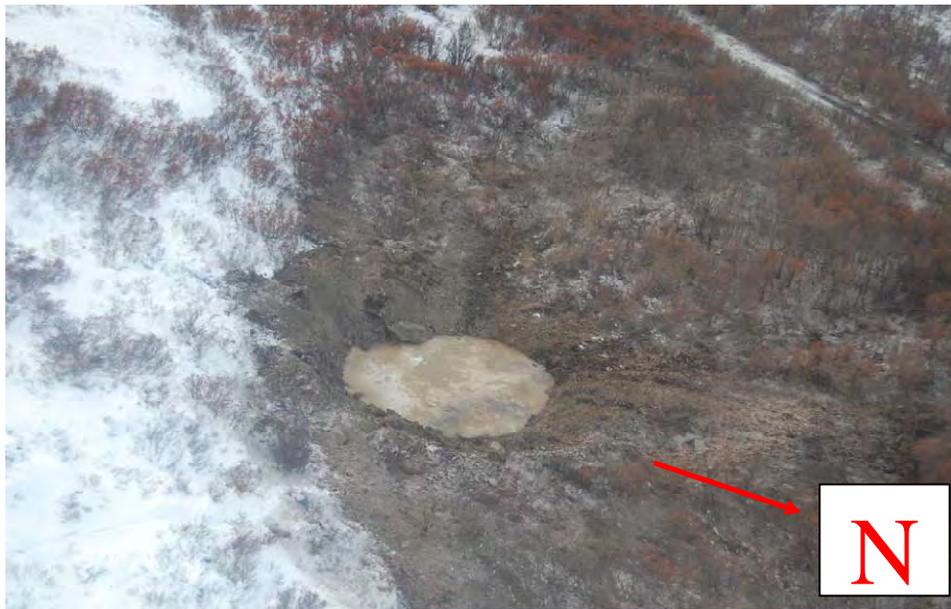
At 19:43:27L, the MA impacted the ground at 735 KCAS, 1.17M, 48 degrees ND, 47 degrees LWD, 7.4 g, with a VVI of -57,900 fpm. The impact site is approximately 120 NM north of JBER, AK, in the Talkeetna Mountain range. The site is approximately 3,100 ft MSL near the edge of a south-west to north-east running valley. The impact crater is located at the valley floor where it begins to slope upwards towards the southeast. The valley floor is approximately one-half mile wide at this point and has a stream running through it approximately 60 yards west of the impact point. (Tabs J-4 through J-6)

The debris field consisted of small aircraft and engine pieces extending approximately one-quarter mile from the crater. The upslope wall of the crater and aircraft impact angle appear to have focused the debris pattern in a 60 – 80 degree wide arc from west to north. (Tabs J-4 through J-6)

Figure 11 Impact Crater 17 Nov 2010 (Tab S-7)

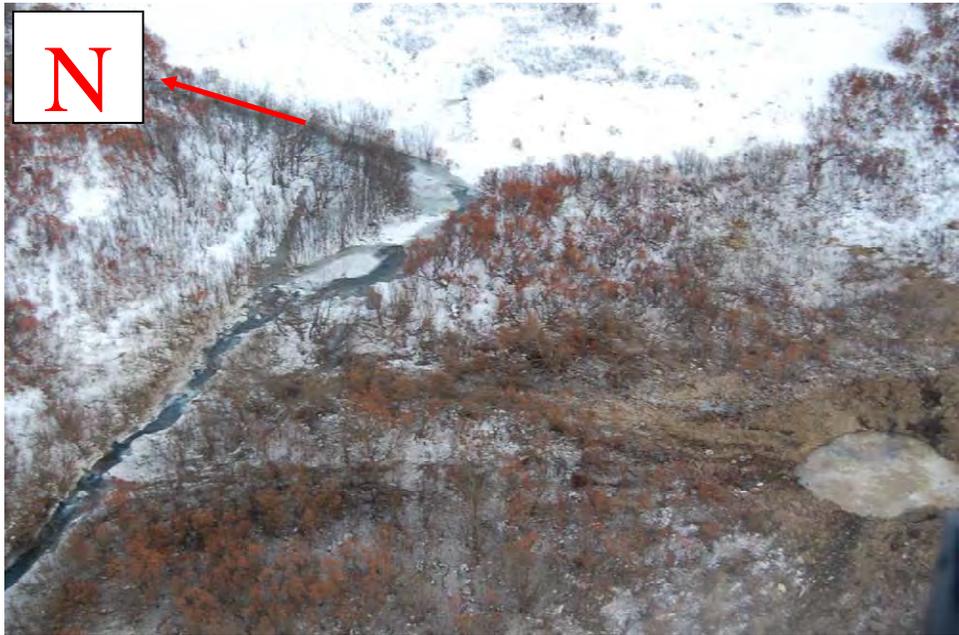
Figure 12 Impact Site. 17 Nov 2010 (Tab S-7)

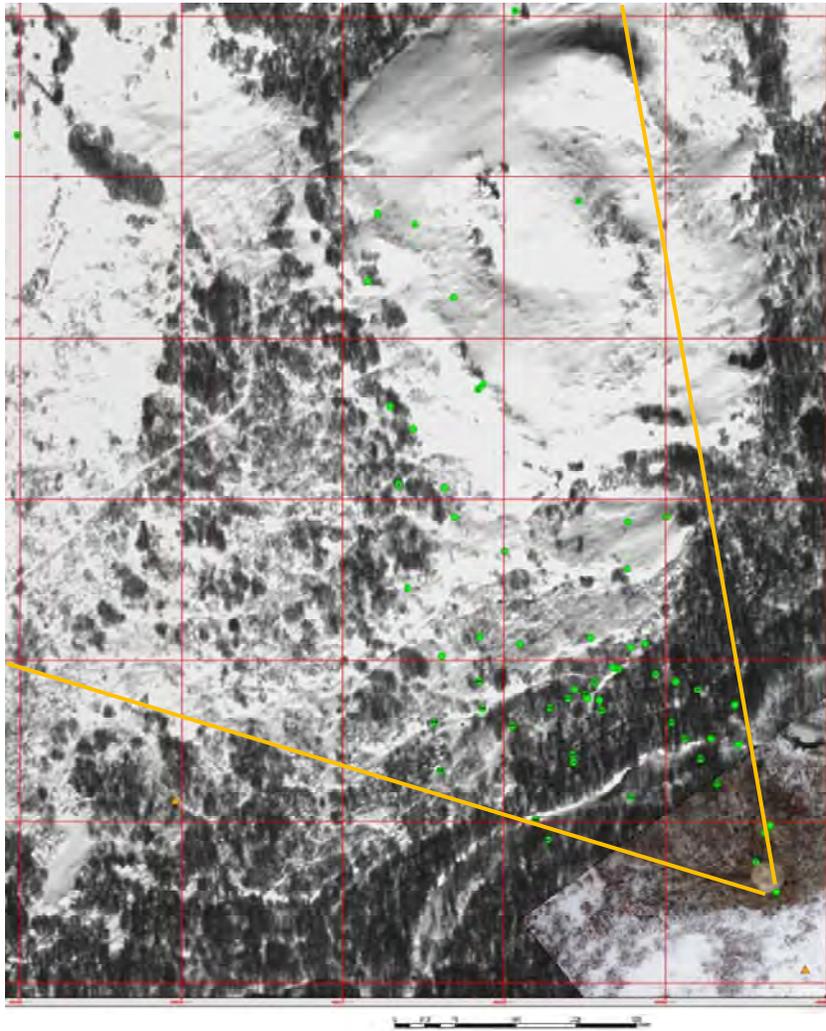
Figure 13 Aircraft Parts Scatter Diagram. Parts represented by green dots. (Tab S-4)

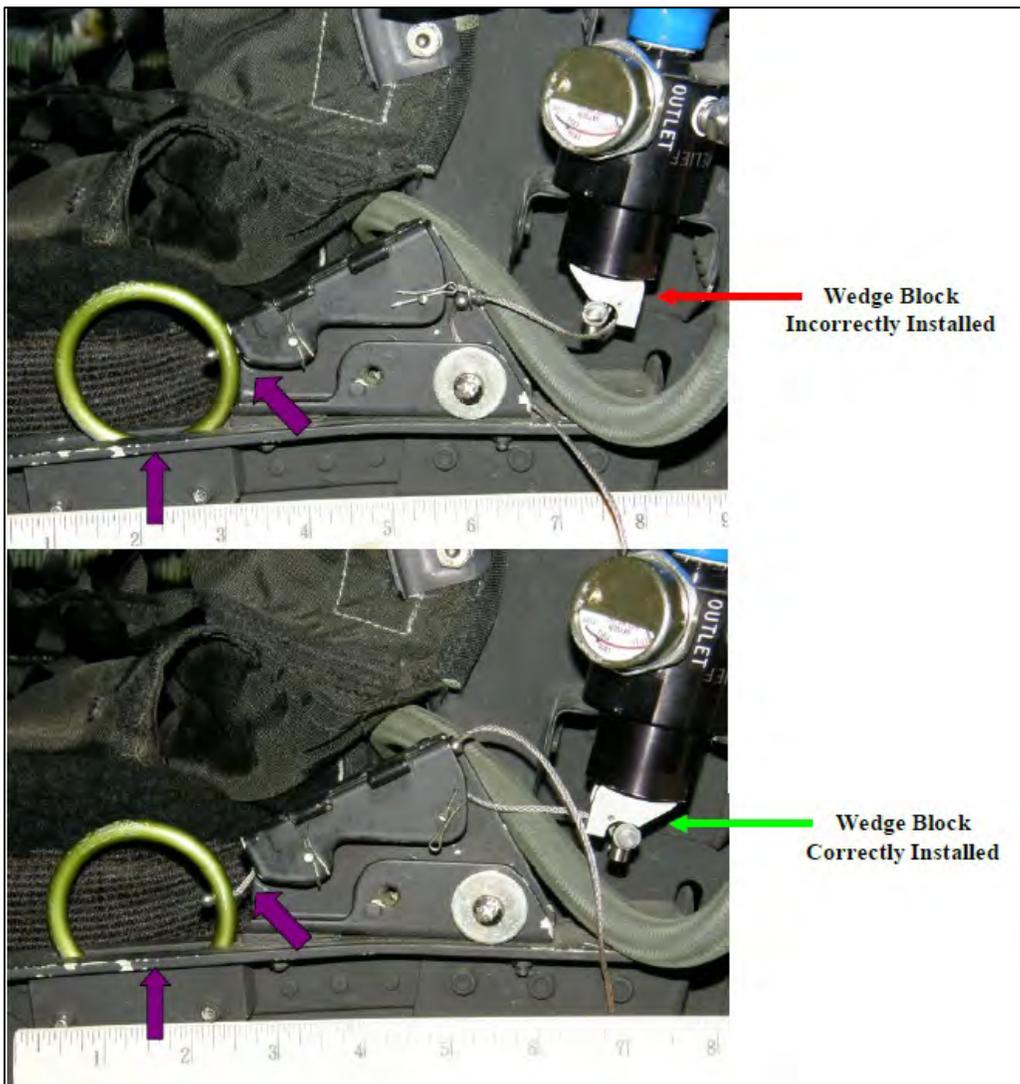
The AFRL report identified that if the EOS wedge block had been incorrectly installed, the wedge block would be unable to move or rotate during manual EOS ring activation. However, during ground simulation the board members were able to initiate the EOS in the incorrectly installed position. (Tab U-4)

Figure 14- The wedge block installed incorrectly (red arrow) and correctly (green arrow). Notice the position of the ring within the seat (purple arrows) based on wedge block position. (Tab Z-6)

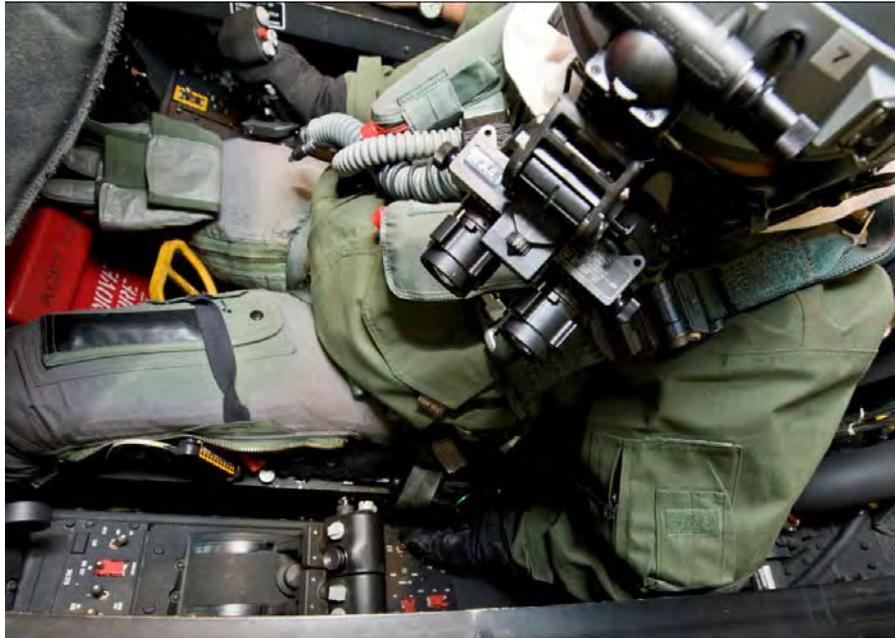
which may have occurred for various reasons, including: the EOS activation ring was dropped or the EOS cable jammed during an attempted manual activation. Retrieval of the ring from between the seat and console would be difficult based on the seat position, night environment, and with personal equipment interference (as discussed in the next section). (Tab CC-5)

Figure 15 - Pilot pulling EOS activation ring. NVG interfering with EOS ring visualization. (Tab CC-5 and Tab Z-7)

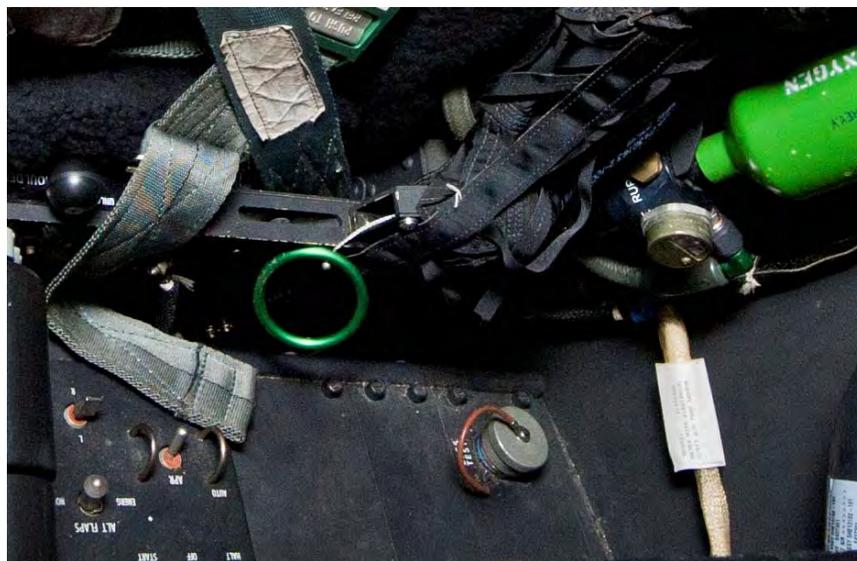
During ground simulation, the manual EOS activation ring was unseated and dropped between the seat and console prior to EOS activation. This was done to simulate a failed initial pull,

Figure 16- Manual EOS activation ring fallen below lip of seat. (Tab CC-5 and Tab Z-8)

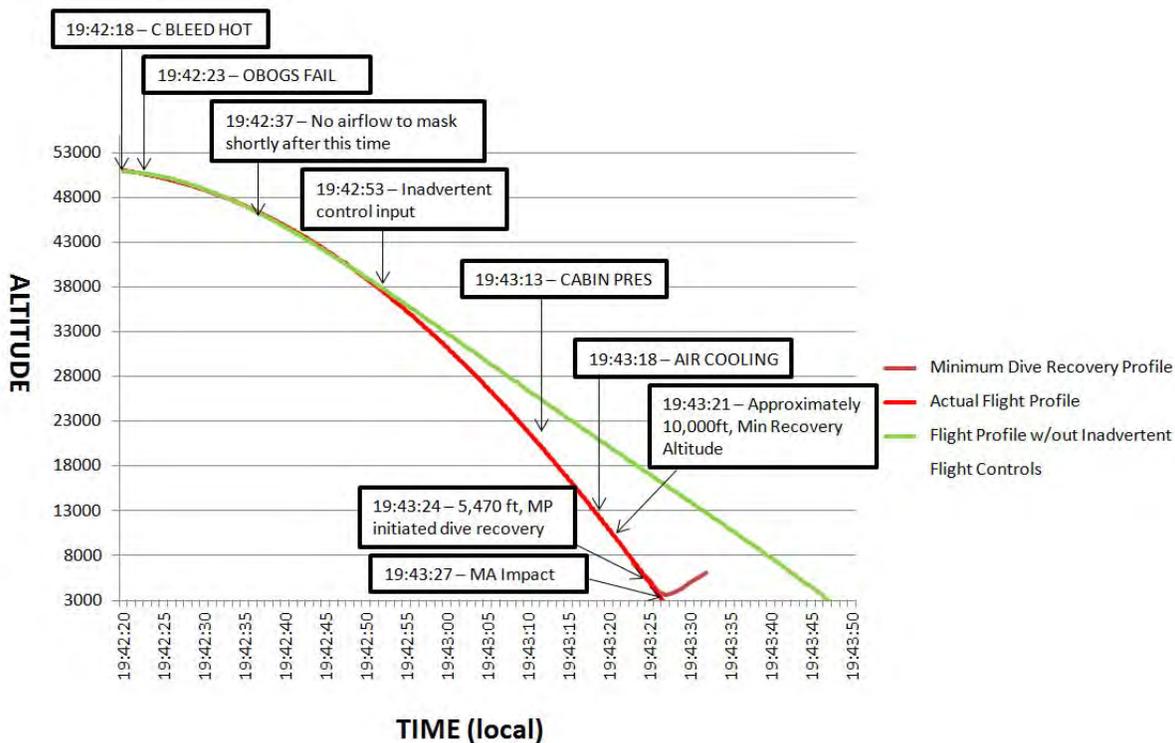
Fifth, the MP was late to recognize the necessity for a dive recovery. At 19:43:27L, the MP impacted the ground because his channelized attention and breakdown in visual scan resulted in unrecognized spatial disorientation. When the MP recognized the MA attitude and altitude, he was below minimum recovery altitude. Figure 17 shows the actual initiation of the attempted dive recovery altitude along with the 1F-22A-1 minimum recovery altitude.

Figure 17 Flight profiles for MS. Actual flight profile (red), flight profile without inadvertent flight control inputs (green), and minimum altitude dive recovery profile (maroon) shown.
